# INDUSTRIAL FIELD REPORT

## OFFSHORE OIL RIG - LEAKING CIP TANK

**LOCATION**  
Offshore Oil rig **SOUTH ARNE** in the Danish North sea.

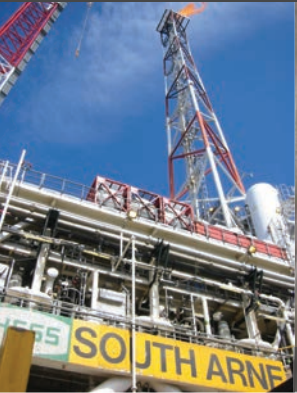
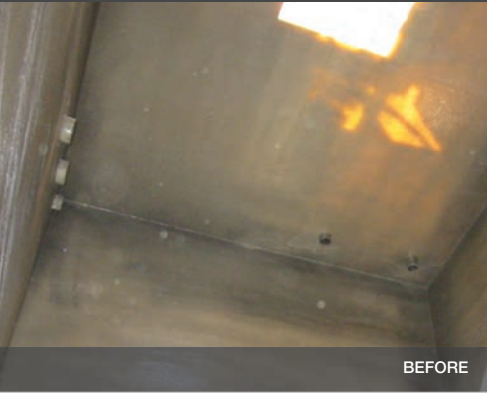
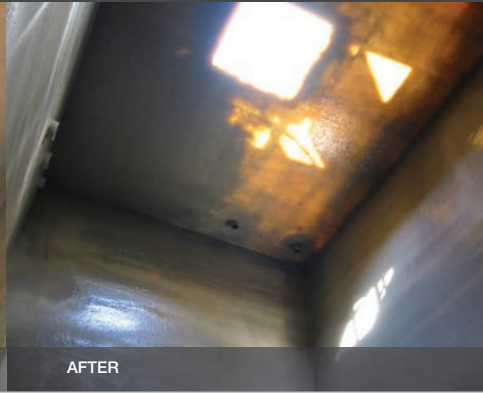
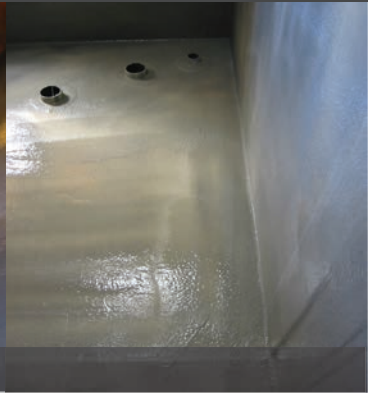
On the oil rig **SOUTH ARNE** in the Danish North sea, they were experiencing a constant loss of fluids in their CIP Tank (clean in place tank). The fiberglass tank didn't have the right structural support, resulting in cracks in the joints of walls and floor.

LINE-X® XS350 was sprayed 2.5 mm (1/8 inch) thick onto the fiberglass with tenacious adhesion.

The coating of LINE-X was completed in 2 hours and back in service soon after with no change in daily operations.
