# LIGHT INDUSTRIAL CASE STUDY

## HEAVY MACHINERY

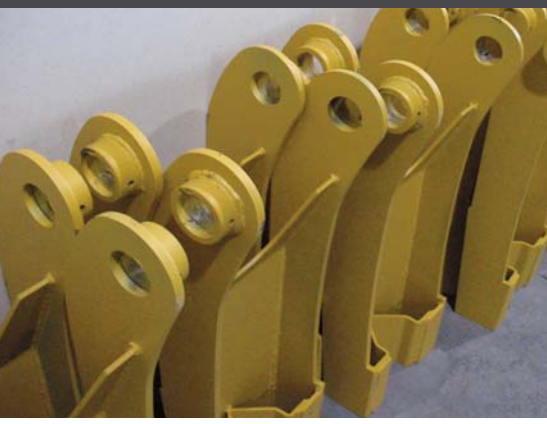
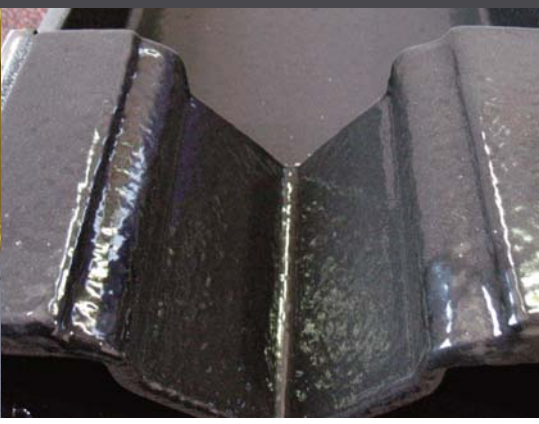
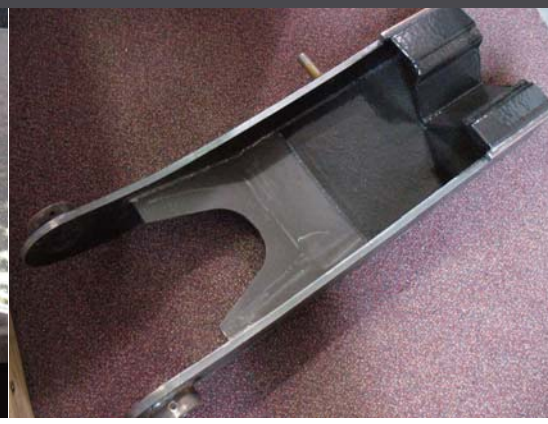
A heavy machinery manufacturer needed a solution for the damage caused inside the hydraulic equipment they manufactured when the equipment is put into use. The quick and inconsistent movement of the machine causes the ram to collide with the cylinder in certain spots, resulting in wear and damage to both pieces.

LINE-X XS-100 was sprayed at approximately 125 mils thick. Per the customer's request, the cylinder component was only coated in the areas where the ram and cylinder could potentially contact. The components were ready for full use in 24 hours.

LINE-X XS-100 was sprayed on the cylinders to protect both the rams and the cylinders from damage. Each cylinder component was sprayed in less than an hour.

The LINE-X coating provided a cushioned operating area for the hydraulic cylinder, resulting in less rework for the manufacturer and fewer warranty claims. The addition of LINE-X to the hydraulic system improved its functionality and value, resulting in a satisfied customer.
