LIGHT INDUSTRIAL CASE STUDY

BRIDGE SUPPORTS

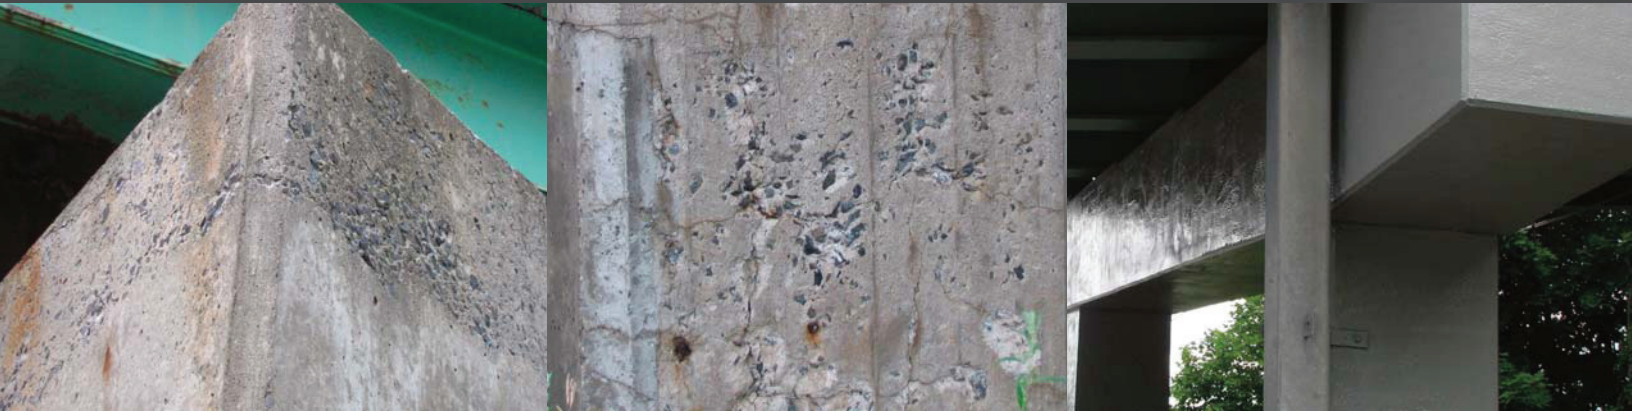
A LINE-X® Franchisee in the Northeast recognized the corrosion of the concrete bridge supports in his area, caused mainly by the calcium and salt used to de-ice roads in the winter. He approached the local Department of Transportation (DOT) bridge maintenance engineers to suggest using LINE-X as a barrier between the contaminants and the concrete supports. At the time the local DOT had no other cost effective options to protect the concrete supports so they decided to give LINE-X a try.

Local DOT officials set up a containment area around the bridge supports and took responsibility for traffic control. DOT also blasted the concrete to remove rust stains and other contaminants from the surface of the substrate. LINE-X coating specialists applied LINE-X SF-515 primer followed by LINE-X XS-350 tinted grey. The coating was applied using an XP2 machine approximately 50-60 mils thick.

LINE-X provided a continuous membrane protecting the concrete bridge supports, extending maintenance cycles. The DOT engineers and regional officials were highly pleased with the results of the application and are looking into future jobs with LINE-X.
