CASE STUDY ::> TARGET APPLICATION

Concrete Water Storage Tank

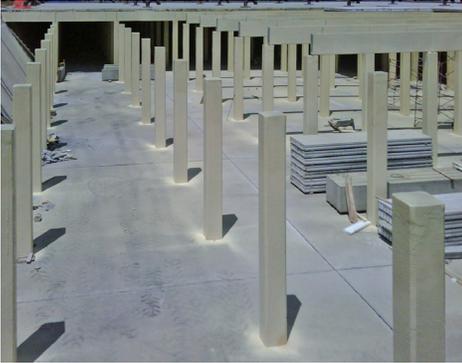
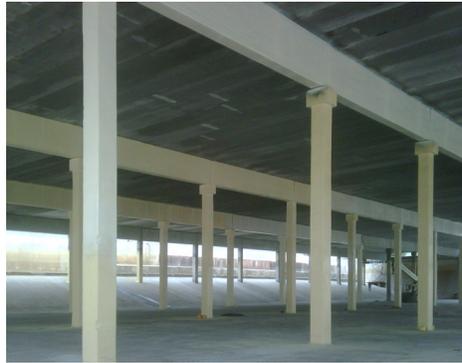
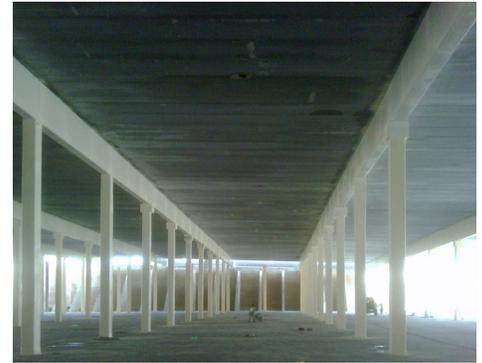
In this project, an existing concrete tank was being refurbished. The construction company determined which concrete pillars and cross blocks would be replaced and coated with LINE-X. Coating any older pillars already contaminated with chlorides was considered a waste of material. Those pillars would be coated in the future when they required replacement.

The new concrete pillars were first cleaned with compressed air. They were then primed with 3-5 mils of LINE-X XS-515.

After the appropriate cure time, the pillars were coated with 80-100 mils of XS-350.
