LINE-X BODY ARMOUR: Full Body Truck (ULTRA)

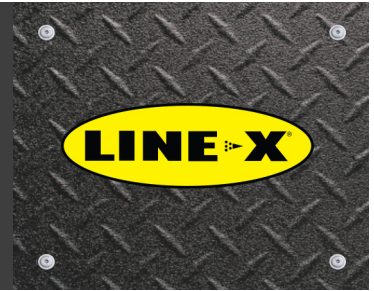
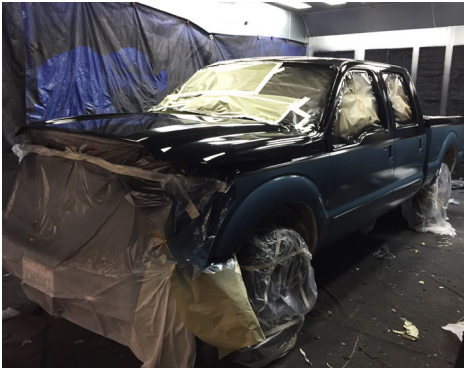
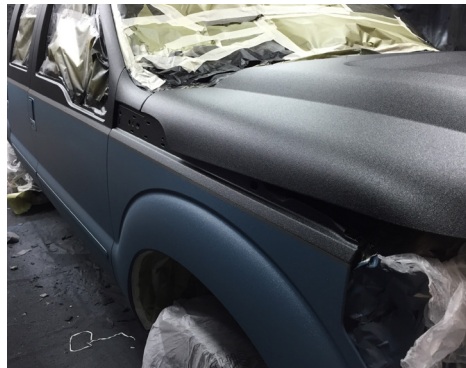
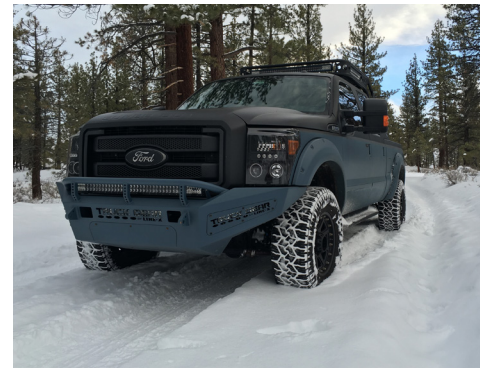
After a year and half, the full body truck sprayed (pictured) shows zero signs of fading, scratching, or other blemishes despite 30,000 hard driven miles and daily abuse of construction jobsites, off-roading in extreme desert environments, and exposure to mountain snow and salty roads.

To start, various parts of the truck such as bumpers, grill, mirrors, bed, tailgate, factory badges trim pieces were disassembled and/or removed prior to spraying. All areas not receiving the coating were masked off to minimize overspray. The metal surfaces were then prepared by sanding, cleaning, and priming (using LINE-X XPM or Fast Cure Primer) to maximize coating adhesion.

LINE-X ULTRA was then applied at high-temperature and high-pressure using industry exclusive specialized equipment at approximately 10-15 mils thick. Once cured, masking materials were carefully removed and truck parts were reassembled.
