# LINE-X BODY ARMOUR: Full Body Truck (ULTRA)

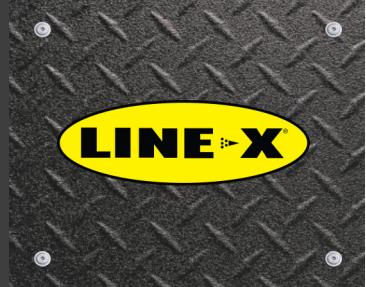
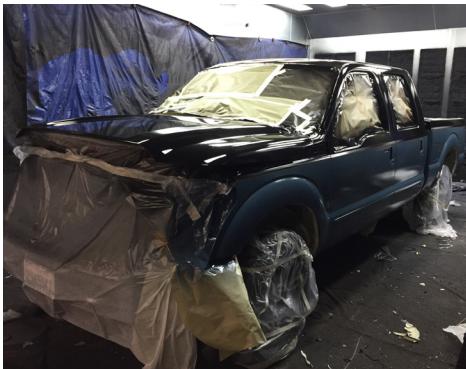
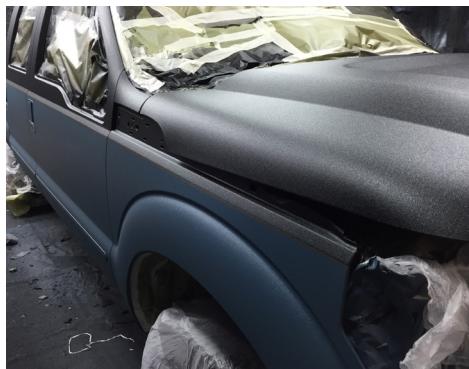
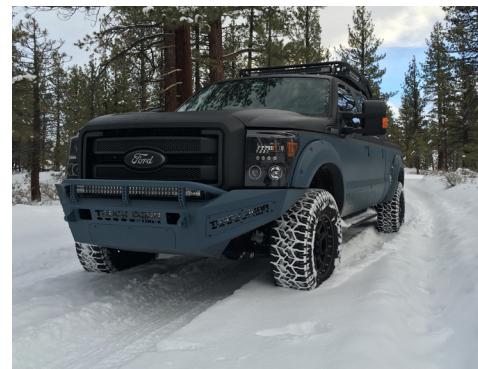
After a year and half, the full body truck sprayed (pictured) shows zero signs of fading, scratching, or other blemishes despite 30,000 hard driven miles and daily abuse of construction jobsites, off-roading in extreme desert environments, and exposure to mountain snow and salty roads.

LINE-X ULTRA was then applied at high-temperature and high-pressure using industry exclusive specialized equipment at approximately 10-15 mils thick. Once cured, masking materials were carefully removed and truck parts were reassembled.
