CASE STUDY ::> TARGET APPLICATION

# HVAC Cooling Tower

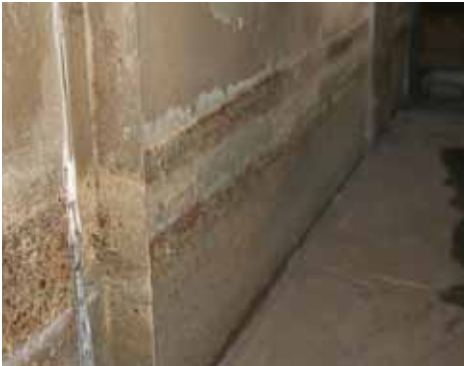
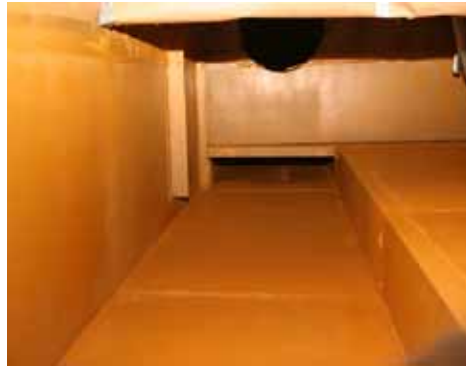
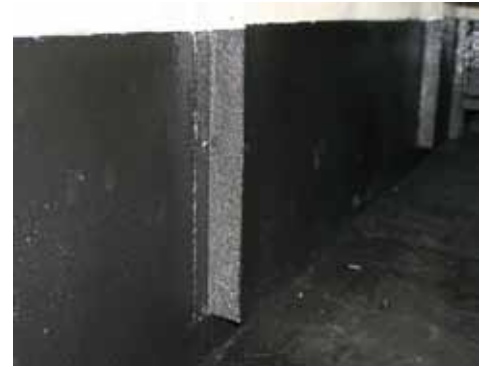
Water that evaporates from the system is made up by float valve and feeder pipe arrangement. Due to the fact the water is in constant motion and entraining a great deal of air, the sump area tends to collect many contaminants which accelerates its corrosion and deterioration.

LINE-X XS-350 was used to coat the bottom of the sump and 24" up the walls sealing the pan and protecting the galvanized steel from corrosion. To avoid taking the equipment out of service for longer than necessary, this work can be completed on site using a portable LINE-X machine.

The cooling tower was drained and allowed to dry. The surface was cleaned and prepared using media blasting. The LINE-X team masked off all areas not intended for coating including the fans and fan motors. The bottom and sides of the sump were primed using LINE-X FCP Primer. After priming, LINE-X XS-350 was applied to complete the application.
