LIGHT INDUSTRIAL CASE STUDY

RESTAURANT GARBAGE CANS

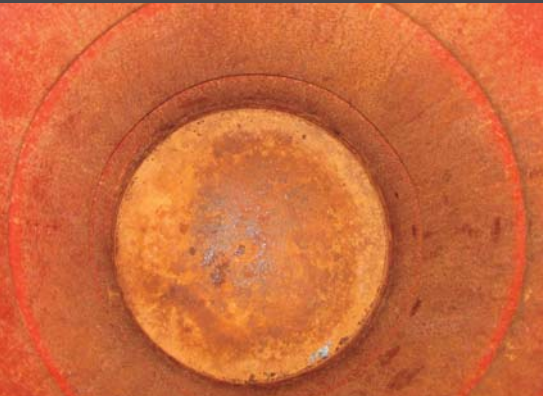
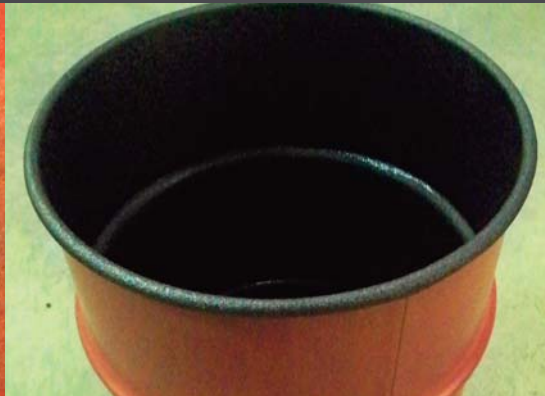
The local branch of a popular restaurant chain was experiencing serious decay in their steel garbage cans. The cans are essentially steel drums approximately 30 gallons in size. Food waste, which is extremely corrosive, consistently makes its way to the bottom of the cans and is difficult to clean out. As a result, the cans rust out and must be replaced every 6-12 months.

LINE-X XS-100 was applied at approximately 60 mils to the inside walls and floor of the cans to provide corrosion protection. The cans were completed within one day and ready for use that evening.

Three new garbage cans were brought to the LINE-X shop where they were sanded with 80 grit sandpaper. The cavity at the bottom of the cans where they had been pinch welded was hand sealed with the LINE-X patch kit to ensure a complete seal and 36" masking paper was secured under the lip at the top of the cans. No wire trim was required.

Using a Fusion gun with a flat tip to accommodate the small opening and awkward ribs on the sides of the cans, LINE-X XS-100 was sprayed to 60 mils. The LINE-X coating was brought up and over the lip of the barrel. The machine pressure was lowered to 800-1000psi for the flat tip.
