LIGHT INDUSTRIAL CASE STUDY

SAND BLAST CABINET

with LINE-X

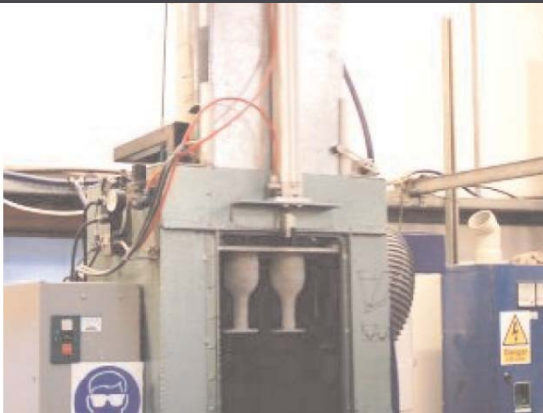
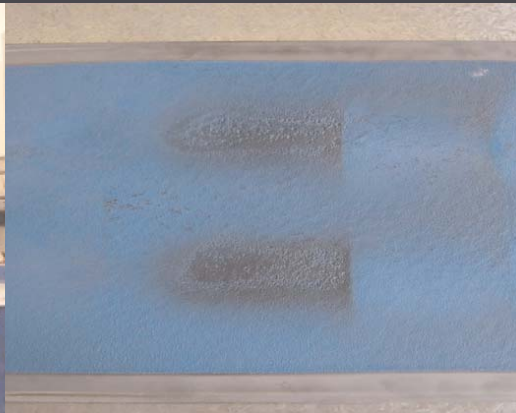
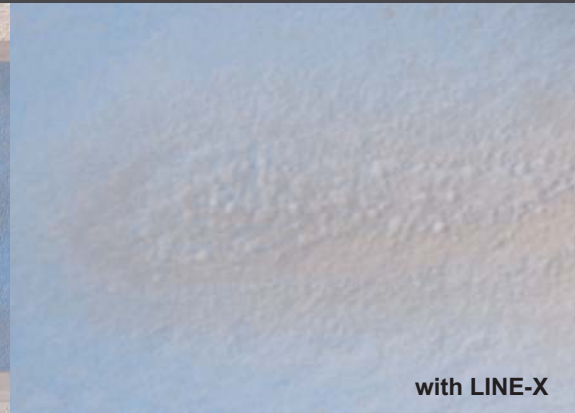
The largest producer of reclaimed glassware in the world uses a sand blaster to frost their goblets and tumblers. Due to the force of the sand blasting, the original door made of 5mm thick mild steel eroded forming a hole within approximately 12 weeks time costing the company replacement fees and production downtime.

The panel was subject to high pressure sand blasting for a period of 6 months, after which it was returned to LINE-X for evaluation. The results were outstanding. In the 6 month period, only 2.5mm of the LINE-X had been worn away under the harshest conditions.

A 1.5mm galvanized steel panel was used. The panel was shot blasted to increase the surface profile, primed and then sprayed 5mm thick with LINE-X® XS-100.

LINE-X XS-100 was chosen due to its high impact absorption properties and sprayed on a 1.5mm galvanized steel panel to replace the original steel door.
