LIGHT INDUSTRIAL CASE STUDY

TRASH COMPACTOR

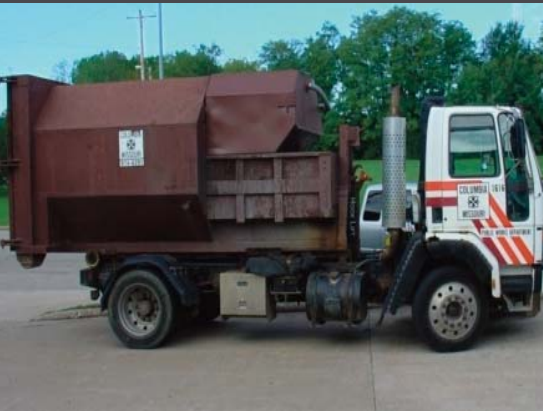
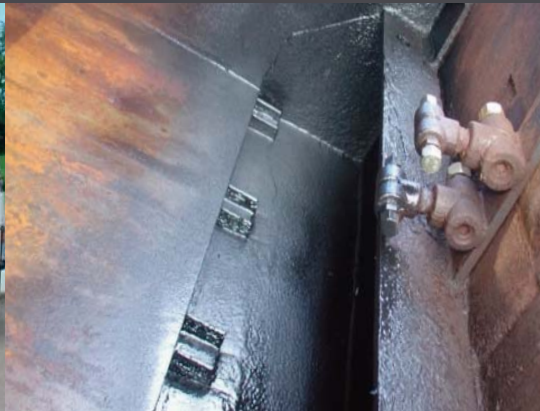
A city municipality was experiencing corrosion issues in the tray that contains the hydraulic compacting ram and hoses of their trash compactor. The corrosion was accelerated by the caustic runoff from the waste. The City needed a solution that would resist the runoff, protect the hydraulic equipment and increase the overall maintenance cycle of the equipment. They needed the solution in a time efficient manner preventing downtime of the equipment.

The trash compactor was brought to the local LINE-X® shop after having been white blasted to remove rust and contaminants. The substrate was then cleaned and primed with SF5-15 to aid in bonding and to prevent rust from spreading under the LINE-X should the coating ever be pierced. After allowing the primer to flash, the compactor was coated with standard LINE-X XS-100 to a thickness of approximately 120 mils (one eighth of an inch) to help protect against impact and abrasion as well as resist corrosion from caustic runoff.

LINE-X XS-100 was used to coat the trash compactor. The application was completed in eight hours and the equipment was back in service the next day with no change in daily operations.
