Underground Water Reservoir

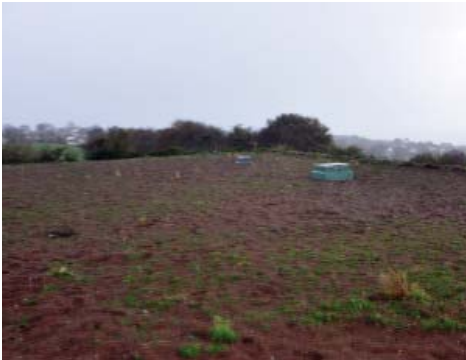
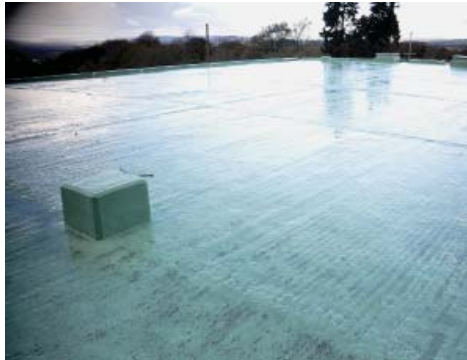
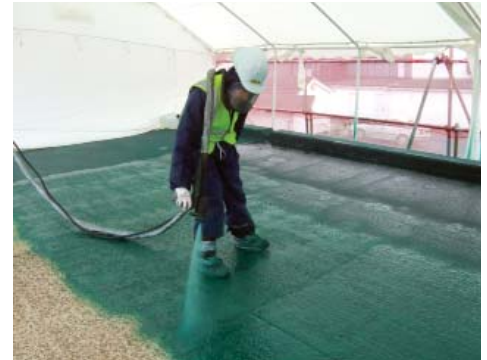
Constructed 30 to 40 years ago, the concrete roofs of the reservoirs have become porous potentially allowing dirty rain water and farming chemicals to penetrate the concrete and enter the drinking water.

LINE-X sealed the concrete roofs using LINE-X Aquasurethane Extreme.

The customer was responsible for removing the dirt covering the reinforced concrete roof. The LINE-X dealer cleaned the roof of residual dirt and soil and cleaned the concrete by pressure washing with water.

LINE-X Aquasurethane Extreme was applied to a thickness of 125 mils.

Following the application, the customer restored the dirt cover using a bulldozer. Once the LINE-X Aquasurethane was covered with dirt, no special protection of the coating was needed.
