INDUSTRIAL CASE STUDY

MINING TABLES

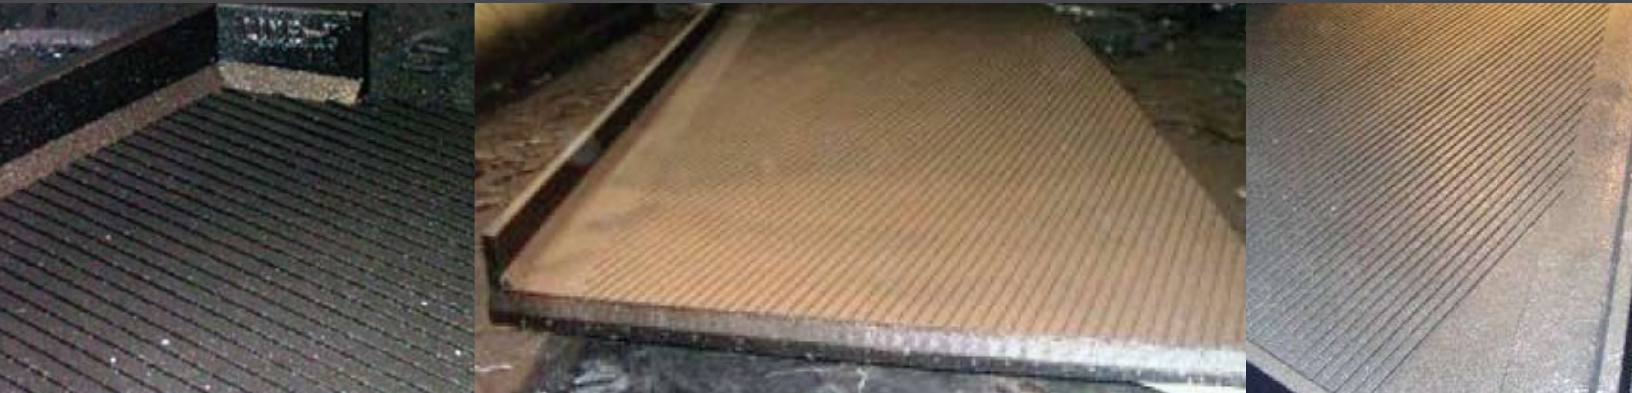
A vermiculite mining company was experiencing abrasion problems on their four shaker tables. The company needed to protect its 8'x25' tables from the abrasion and potential corrosion caused by the continual exposure to rock and slurry. Previous attempts at protecting the plywood and pine surface included using a paint-like plastic product, but it did not adhere well to the substrate and failed.

The tables, made of plywood and pine, were delivered to the LINE-X® shop where the hardware was removed and the surfaces were sanded to remove any remnants of the previous paint. The tables were then completely encapsulated in XS-100, at an approximate thickness of 120 mil.

Several initial dust passes were made to spray the wood, particularly important since the wood was encapsulated. Next, wet passes were applied to gain thickness. This process allowed the steam to escape and did not allow “blisters and volcanoes” to form.

The four tables were sprayed with LINE-X XS-100, completely encapsulating the pieces. The substrate was wood and no primer was needed.

LINE-X XS-100 provided excellent impact and abrasion resistance against damage from rock and slurry while the proper preparation of the substrate resulted in excellent adhesion. This process greatly extended the maintenance cycle of the shaker tables.
