# LIGHT INDUSTRIAL CASE STUDY

## MUNICIPAL APPLICATION – CHIP & SEALER SPREADER

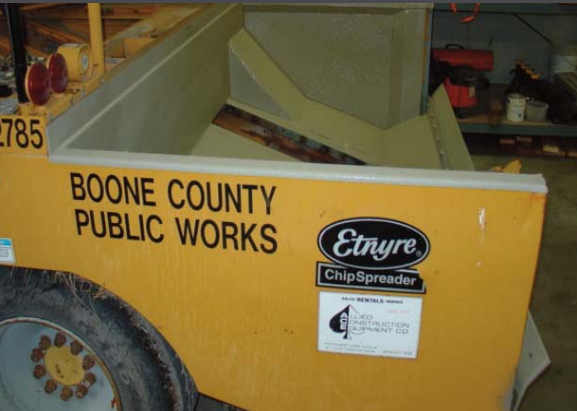
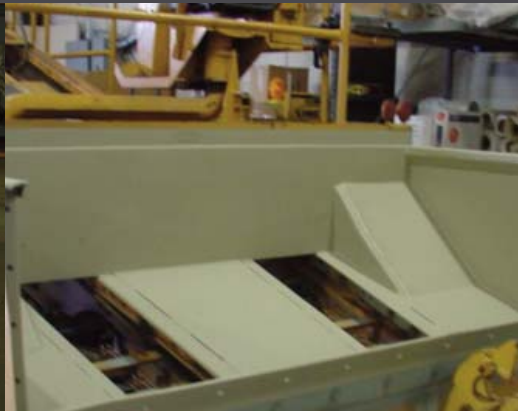
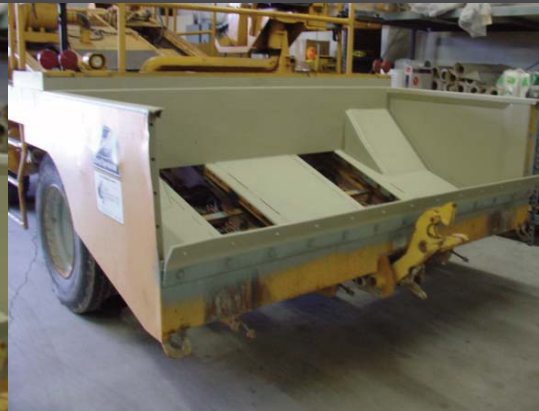
The County Public Works Department resurfacing spreader required continuous repair each year. Since the spreader is used only a few months of the year, the department was forced to park it outdoors in the elements the remaining several months. The spreader would rust and corrode requiring extensive repair before use the following year. Public Works sought a solution for this ongoing costly problem.

The spreader was etched to a “White Blast” removing all rust and contaminants. After masking all areas not being coated, the LINE-X SF-515 primer was applied to ensure maximum adhesion and corrosion protection. Once the primer window opened, the LINE-X XS-350 was applied (XS-350 was chosen over the XS-100 due to the vehicle’s heavy service environment). The LINE-X was applied approximately 125 mils thick.

LINE-X provided a high impact and abrasion resistant coating to the resurfacing spreader to prolong the life of the hopper. This procedure allowed the spreader to be parked outside when not in use without worry of rust and corrosion, saving the department money and downtime for repairs each year.
