# Dialysis Clinic

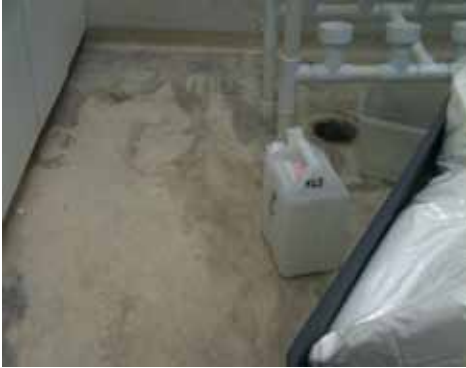
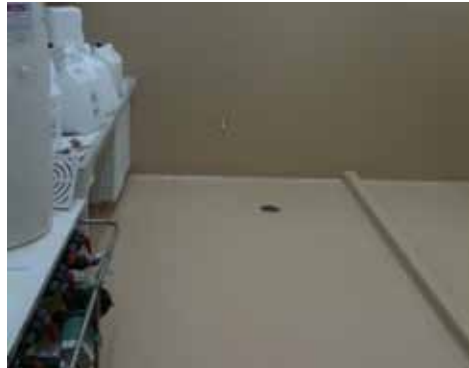
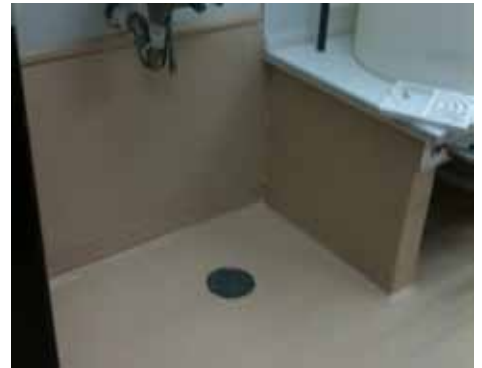
Dialysate is the main chemical used in dialysis and is very corrosive. Epoxy and vinyl floor coatings fail because any spilled or leaked dialysate penetrates the coating and attacks the underlying concrete floor.

When the failure is ignored, moisture leaks down to lower floors and walls leading to more damage.

LINE-X created a chemical and waterproof membrane on the floor and walls using LINE-X XS-310.

Before spraying, the LINE-X team repaired the damaged areas of the concrete floor. Then XS-310 was applied to the floor and 5 feet high along the wall at a thickness of 1/8th inch. This protected the area from chemical spills and water leakage while providing a tough surface that would withstand repeated use and maintenance.

A layer of ASPART-X was applied to allow for easy clean-up. This would ensure that the dialysis area maintained proper sanitation for patients.
