LIGHT INDUSTRIAL CASE STUDY

ENCAPSULATED FLOATATION

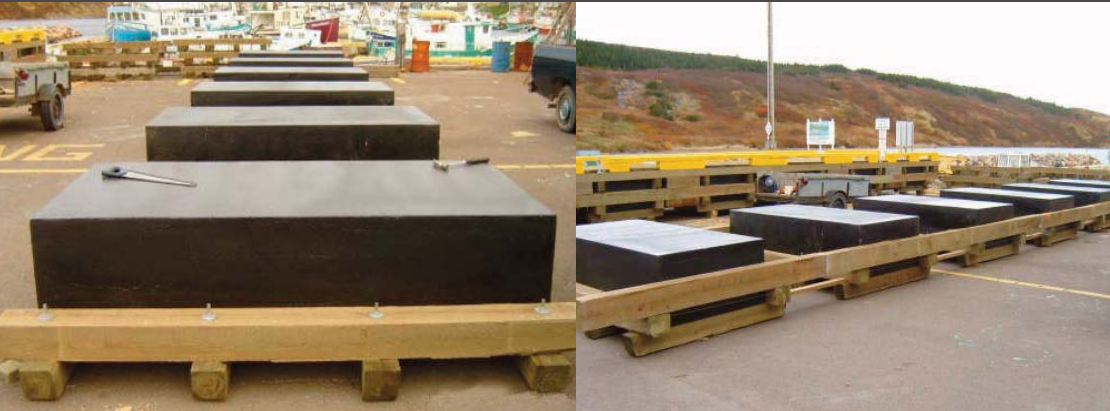
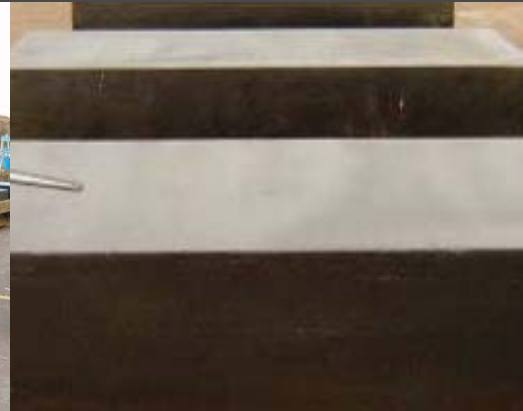
LINE-X Protective Coatings sprayed over EPS (extruded closed cell foam) offered a multi-faceted solution to the environmental and maintenance issues presented by unencapsulated forma. The direct encapsulation means no voids exist which can trap water and reduce buoyancy.

Floats can be constructed to any size or shape and LINE-X provides a seamless monolithic membrane. LINE-X also provides abrasion, impact and chemical resistance and does not support organic growth.

The LINE-X encapsulated billets at the docks have been in place for 12-months of the year, over three years and have experienced no problems or concerns with the application.
