# LIGHT INDUSTRIAL CASE STUDY

## FAN SHROUDS

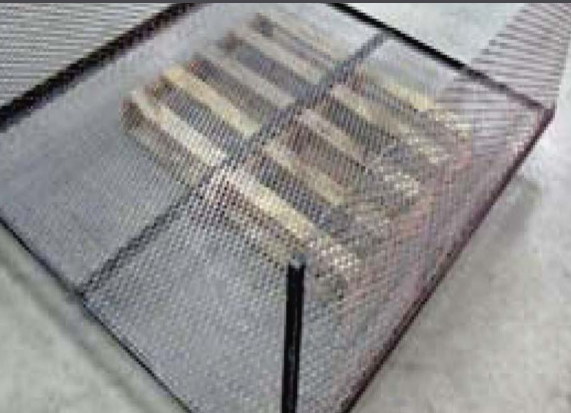
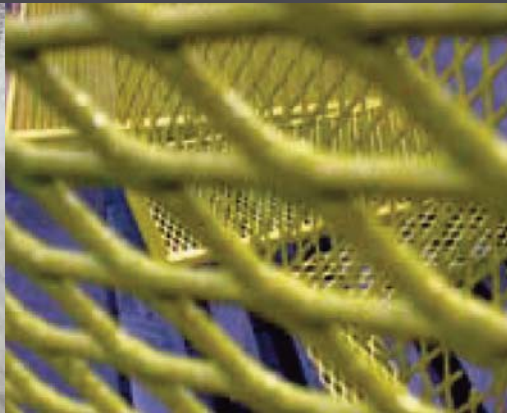
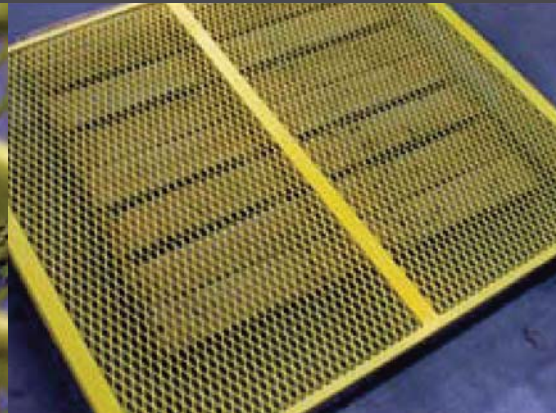
Several fan shrouds were located in an open warehouse. The exposed sharp edges of the shrouds created a risk of injury to people in the warehouse. Because the shrouds were black they blended into the background, accelerating the risk for accidental injury. OSHA considered the fan shrouds to be a workplace hazard.

The fan shrouds were removed from their assembly and brought to a local LINE-X® store. There, the steel was cleaned using DuPont® 5717S Metal Conditioner and etched using 36 grit paper and a DA sander. After etching, debris was blown from the substrate and the steel was wiped with a mild solvent. LINE-X XS-100 was applied in yellow to the substrate, completely encapsulating it. LINE-X® XTRA was then applied in Safety Yellow.

The shrouds were replaced without any fitting issues. LINE-X provided protection against the sharp edges of the fans while making them more visible with the yellow color-coded LINE-X XTRA coating. The changes satisfied OSHA and passed subsequent inspections. The durability of LINE-X ensures that the coating will last the life of the unit.
