LIGHT INDUSTRIAL CASE STUDY

FOOD PROCESSING FACILITY

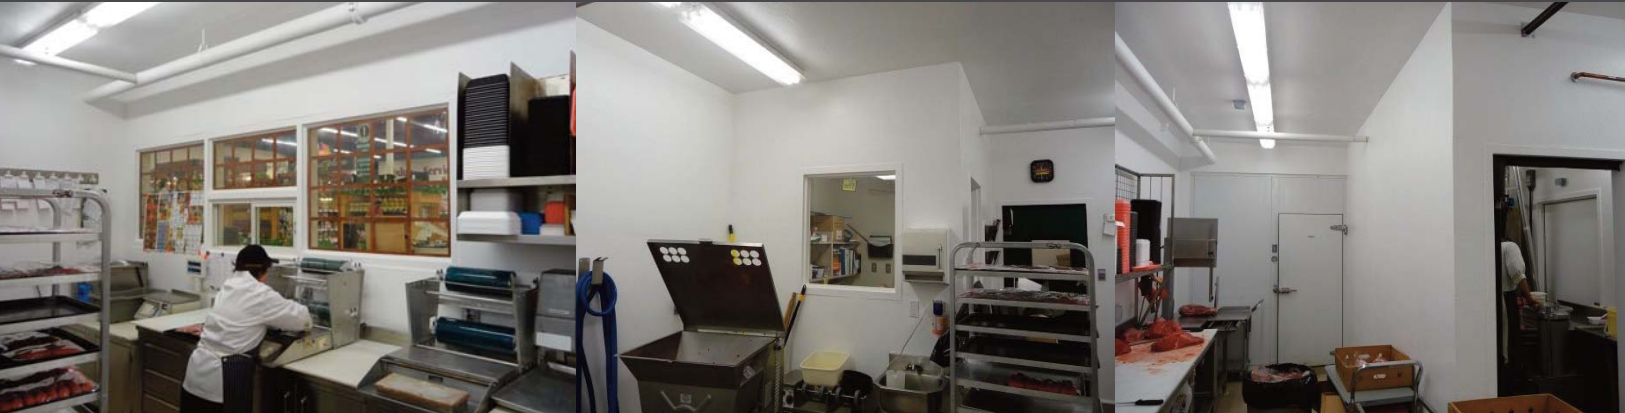
A major grocery chain outlet contacted LINE-X seeking a solution to an ongoing issue of maintenance and cleaning difficulties in their meat cutting department. Painted surfaces were difficult to clean and peeling paint from overhead duct runs presented an unsanitary and unappealing appearance.

With very little downtime for the client, the meat cutting area now presents a bright and clean appearance. The monolithic seamless membrane is very easy to clean and future maintenance has been drastically reduced.

LINE-X® professionals carefully prepped all areas and protected equipment and surfaces not to be sprayed. Utilizing a mobile system, LINE-X XS-100 was applied to all targeted surfaces. With its quick set-up time of 2-3 seconds, the product can be applied at any angle without drips, runs or sags. A color matched food-safe topcoat is then applied completing the procedure.

LINE-X XS-100, bearing approval by the for Incidental Food Contact, and also approved for Potable Water under the ANSI/NSF 61 Section 5, was the product of choice to solve the customers problems. LINE-X offers superb clean-ability, impact, abrasion and chemical resistance, and has the inherent characteristic of being non-supportive of organic growth.
