# LIGHT INDUSTRIAL CASE STUDY

## MIXING SHAFTS

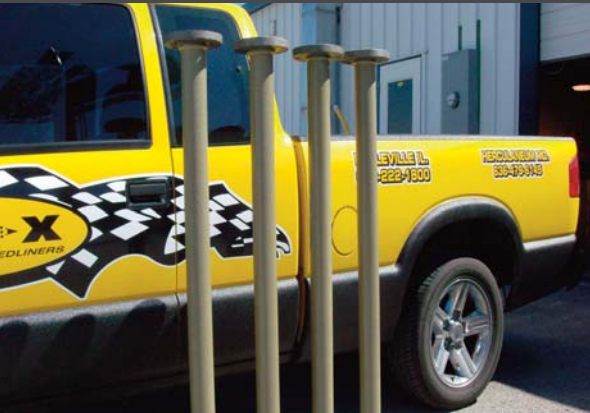
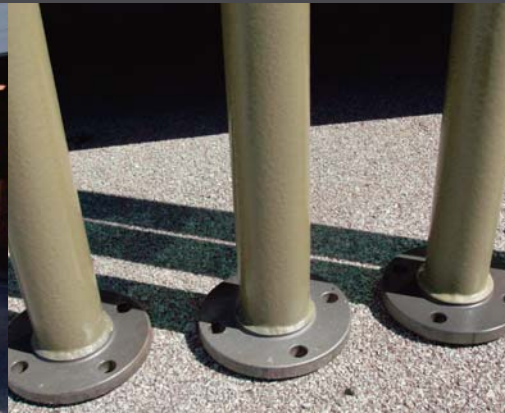
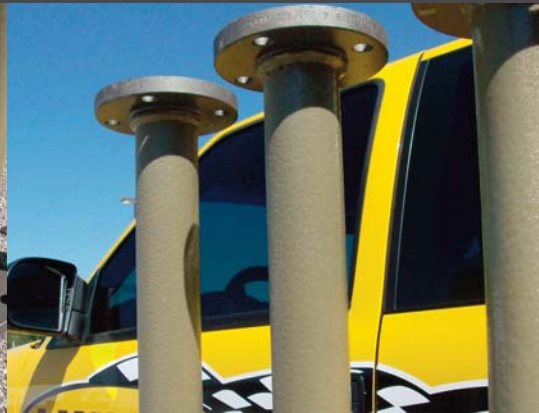
A retooling subcontractor needed substantial, lasting protection on four 5' tall mixing shafts. In use, the shafts are connected to large polyurethane mixers and immersed in a chemical separating tank where they agitate heterogeneous mixtures of chemicals to draw out pure chemicals.

Originally the shafts had been coated with an epoxy, but the coating was quickly degraded by the chemicals and the shafts began to rust. The retooling subcontractor then tried outsourcing the protection to a urethane coatings company, but this polyurethane material didn't hold up over time. The shafts needed to be protected by a product that had high chemical resistance and wouldn't flake or melt off into the chemical bath.

The subcontractor took the four mixing shafts to a sandblasting company and then delivered the etched shafts to the local LINE-X® store. The mixing shafts were primed with LINE-X SF-515 and then were sprayed with LINE-X SE-500 approximately 80-100 mils thick. Only the cylindrical parts of the shafts were coated. The tops and bottoms were taped off. Excluding the waiting period for the window of the primer, the project required about two hours of shop time.

The exceptional chemical resistance of LINE-X SE-500 was a great fit for the mixing shafts. After being sandblasted and primed with LINE-X SF-515, the shafts were coated with LINE-X SE-500 and back in service in less than 48 hours.

LINE-X SE-500 provided excellent protection against the corrosive chemicals that had previously degraded the shafts, the epoxy, and other polyurethane coatings. The substrate was properly prepped with an aggregate blast and SF-515 primer allow the product to meet the subcontractor's requirements for adhesion.
