CASE STUDY ::> TARGET APPLICATION

2nd FLOOR PAVER DECK

LINE-X
PROTECTIVE COATINGS

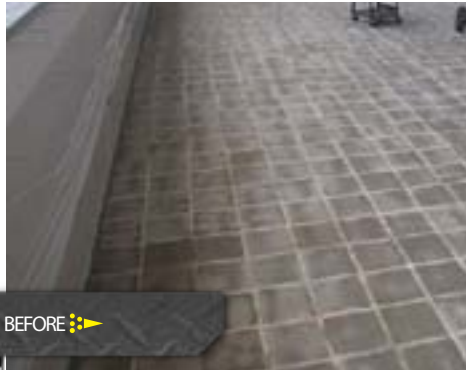
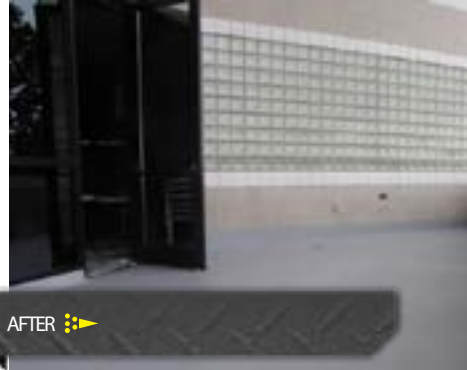
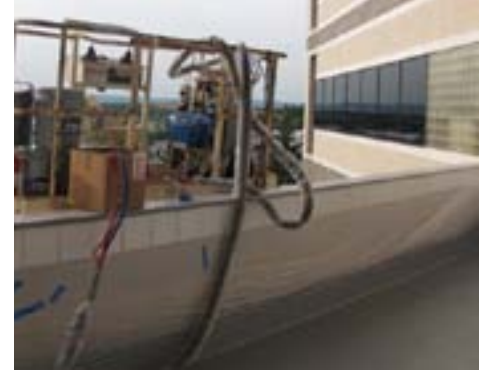
The Hospital & Healthsystem Association of Pennsylvania administration office needed a solution for a second floor deck that was leaking onto the first floor entrance lobby. Built about 25 years ago of a watertight membrane under concrete pavers and epoxy grout, the deck had deteriorated significantly and grout joints were popping up in some areas allowing water to seep in. Two bronze floor drains were intended to provide a place for the water to drain off the deck.

LINE-X XS-100 was sprayed in light grey on the floor of the deck and up the walls to create a monolithic, watertight membrane. It was then topcoated with LINE-X® XTRA to protect it from direct sunlight.

The deck looks great, provides the slip resistance that the customer wanted and no longer leaks. The customer is very pleased with the results, especially since the solution came with a much lower price tag than the quote to have the deck rebuilt using the same materials.

The deck was prepped by grinding down the surface of the concrete pavers with a floor grinder. LINE-X XS-100 was sprayed on the floors, 6" up the wall to the first grout line, and into the floor drains. The grates covering the floor drains were removed and LINE-X was sprayed inside the drains to create a monolithic membrane allowing water to roll off the deck and down the drain. When spraying was complete, LINE-X replaced the bronze grates. The XS-100 was sprayed with aggressive texture to maintain skid resistance. The project was topcoated with LINE-X XTRA in grey. Two coats were applied to ensure UV stability.
