Playgrounds

LINE-X
PROTECTIVE COATINGS

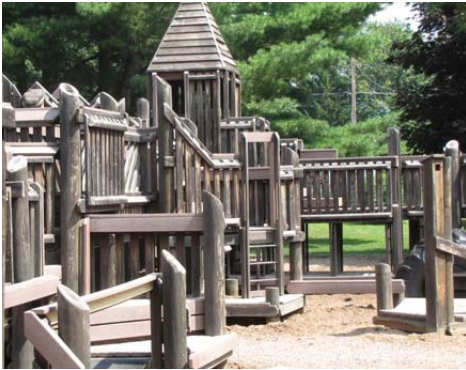
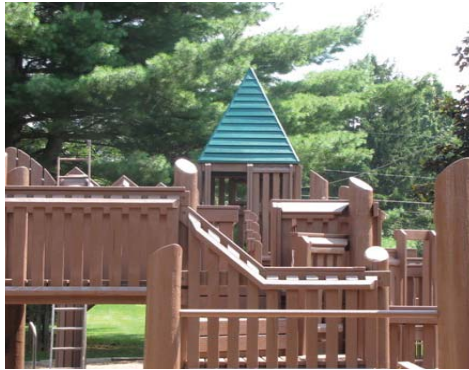
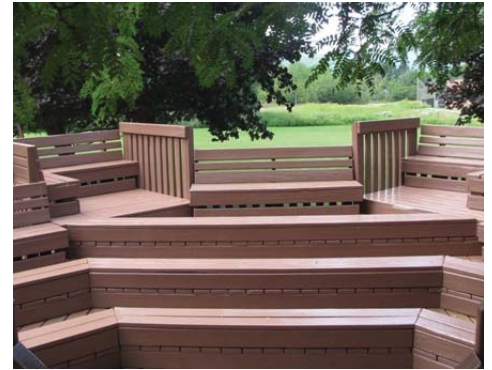
Each piece of pressure-treated wood was coated with LINE-X XS-100 according to the PTA's specifications. The application required approximately one week for two applicators to complete, spraying only in the evenings in order to avoid the moisture from dew.

The LINE-X application is an excellent solution for the pressure-treated wooden playgrounds. LINE-X XS-100 provides an aesthetically appealing appearance, keeps children safe by preventing the wood from splintering, and meets NY State regulations.

- Sawdust moved away from footings and other areas where the structure was close to the ground to allow for easier LINE-X application.
- Footings are cleaned of dirt and contaminants to provide a better surface for LINE-X to bond to.
- Nearby fencing was removed to protect it from overspray, and then reinstalled once the application was completed.

LINE-X masked areas that were not going to be coated, such as chains. LINE-X XS-100 was used due to its excellent bonding abilities to pressure-treated wood. Every piece of wood was coated on all sides. The applicators started applying the coating to the highest surfaces and moved downward. This way, overspray gets on all the lower surfaces and provides plenty of texture. For enclosed areas such as cubbies, the outside was sprayed first. Skid resistance was not required so texture was minimal to normal.
