# LIGHT INDUSTRIAL CASE STUDY

## SERVICE VEHICLES

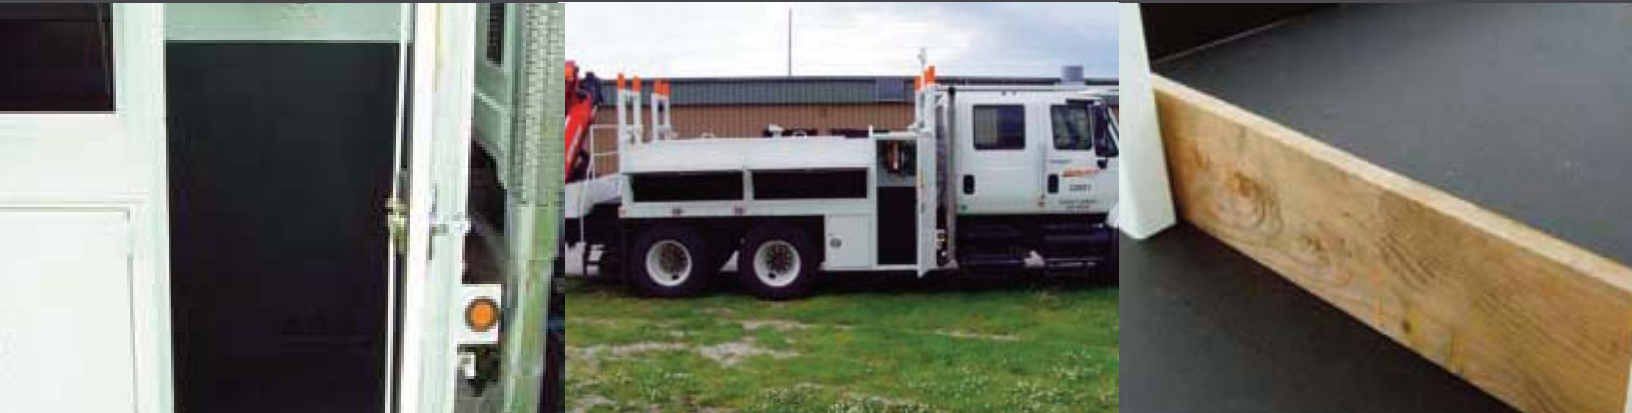
As speciality vehicle paint is not often applied in the same manner as consumer vehicles, the areas for application on the service body vehicles were sandblasted and brought to the local LINE-X facility. The parts were cleaned and primed using SF-515. Once the primer had flashed, standard LINE-X XS-100 was applied at approximately 120 mils (1/8") to each of the cabinets and to the deck of the vehicle.

LINE-X CS-100 was used to protect the risk areas of the service bodies. The entire application took approximately eight hours allowing the vehicles to be back in service the following day with no alteration in operation.

The LINE-X application provides durable, long-lasting protection against impact, abrasion and corrosion. The special LINE-X texture also helps to decrease the risk of employee injury and cargo shifting while providing the professional appearance the client required.
