LIGHT INDUSTRIAL CASE STUDY

SHOWER STALLS

King's Daughters Medical Center in Kentucky had problems with the safety and sanitation of their shower stalls.

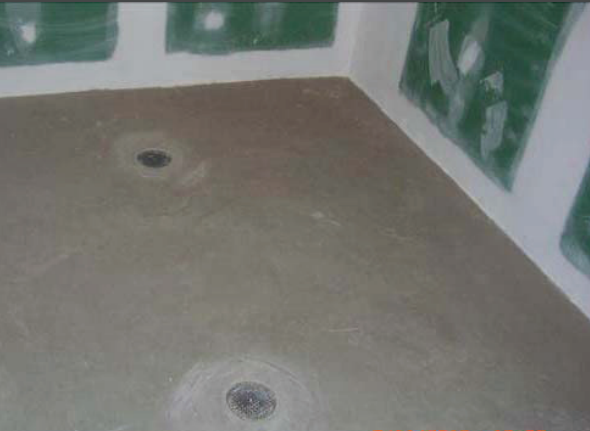
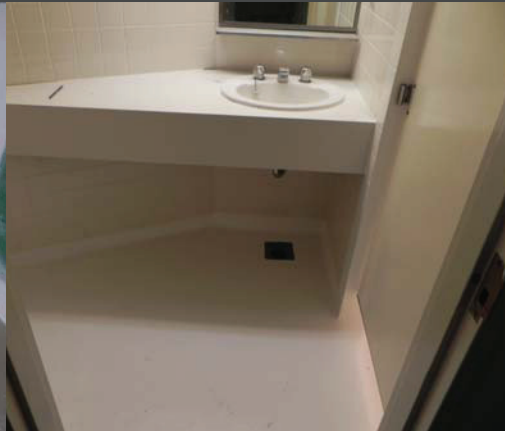
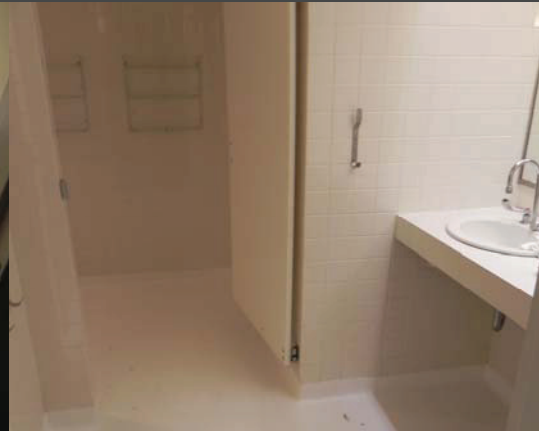
- The showers were tiled, a slip hazard in this wet environment
- The grout was unsanitary, holding onto moisture and creating an environment where mold, bacteria and other germs could grow
- The tile was easily damaged from hospital equipment. Once damaged, moisture seeped behind the tile causing the drywall to deteriorate allowing mold and bacteria to grow in the wall

The floor, walls and ceiling of the shower stalls were coated in white LINE-X XS-350 and topcoated with white LINE-X ASPART-X.

Demolition, reconstruction and fixture removal must be done prior to starting the project. New green board was installed and mud work was completed. Prep includes:

- Walls were cleaned carefully. Liquid was used sparingly or not at all to prevent the drywall and mud from absorbing the liquid.
- Walls were dry dusted.
- Floors, made of concrete with pebbles embedded, required grinding with a DA sander and 40-grit to remove soap scum. In some areas a hand grinder with a disc was used. This was followed with an acetone wipe.
- A basic urethane caulk was used to join the walls and the floor together so that spraying would create a seamless monolithic membrane

The Franchise used an E-10 to complete the job. They used a flat tip to spray smooth walls and a round tip for the textured floor. The ASPART-X filled in some texture on the walls which was desirable, but on the floor they were careful to maintain skid resistance.
