# LIGHT INDUSTRIAL CASE STUDY

## VEHICLE RESTORATION - UNDERCARRIAGE

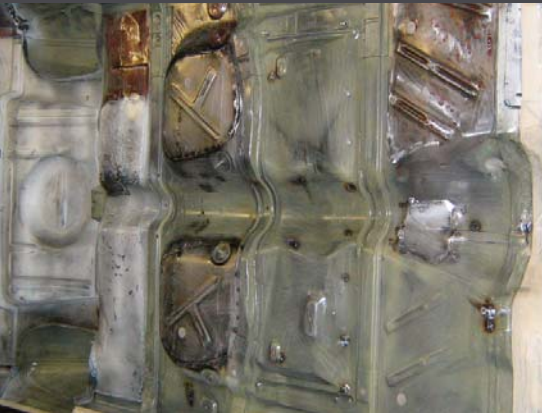
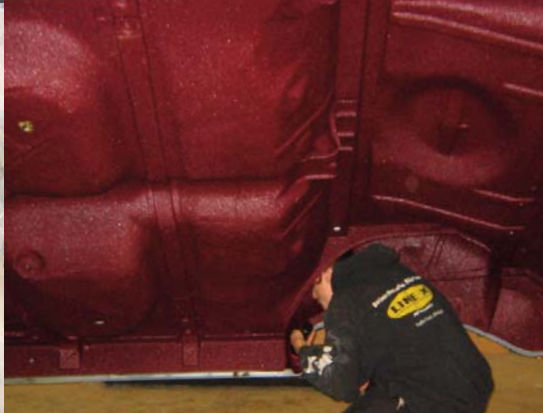
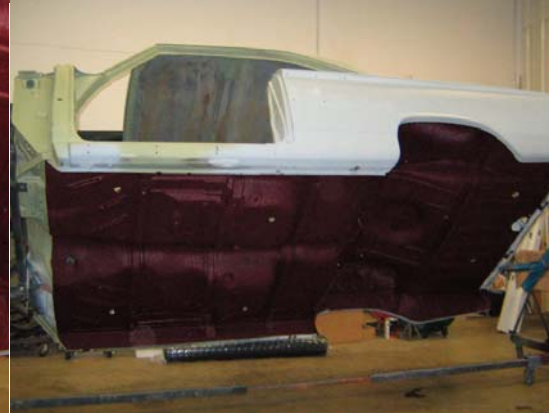
The vehicle was brought into the local LINE-X® facility, on a rotisserie with all the application areas already sandblasted. The vehicle was masked and primed with SF-515. When the application window opened, the vehicle was sprayed with XS-100 to approximately 80-100 mils thick. Though 60 mils would provide sufficient impact and abrasion resistance, the customer chose a thicker application to provide increased sound dampening.

Putting the vehicle on a rotisserie allowed sufficient access to all areas so an even coat could be applied to the desired surfaces.

LINE-X XS-100 was sprayed onto the undercarriage of the vehicle. The entire process takes two days to complete: one day to receive and

mask, another day to prime, coat and spray with LINE-X® XTRA.

The application was a success. The customer was happy to get additional strength for the uni-body sheet metal construction with LINE-X, making the undercarriage more stout and sturdy while also providing protection from road debris. The color matched LINE-X XTRA kept the original “look” of the vehicle the customer was requesting. The process did not interfere with the vehicle performance. LINE-X also provided the added benefit of noise abatement.
