INDUSTRIAL CASE STUDY

WATERPROOF LINING FOR LANDSCAPE DESIGN

Project Overview: Waterproof Liner For Residential Concrete Planters Above Underground Car-park

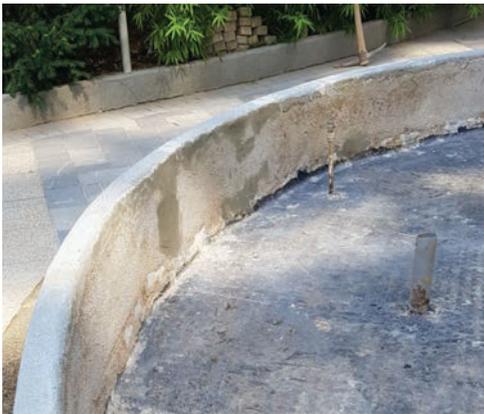
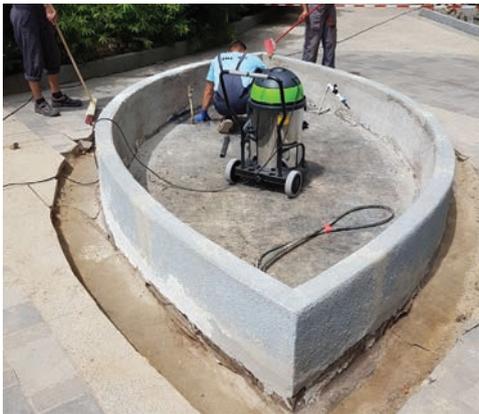
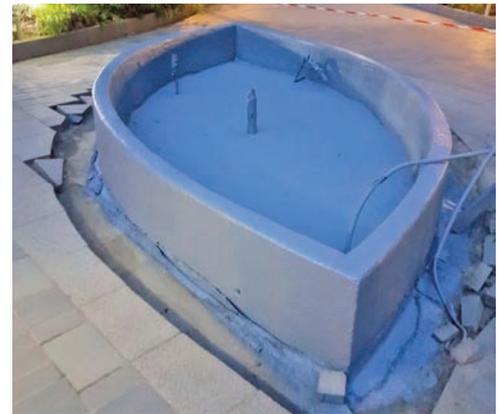
One this particular courtyard in Europe, large concrete planters were leaking water into an underground car park directly underneath the garden. The existing bituminous waterproof lining was rapidly failing and a more permanent solution was needed.

Before any improvements could be made, the existing bitumen liner had to be completely removed. Then the concrete was thoroughly cleaned and ready for a new waterproof solution.

Utilising both a pure and aliphatic polyurea technology, LINE-X applicators completely sealed the concrete creating a seamless waterproof membrane. Then, another layer was added to the interior and exterior of the planter as an additional water barrier and aesthetic finish.

With the LINE-X coating in place, rainwater stopped leaking through the concrete planters into the parking garage below. The final result was a completely watertight seal that will prevent future water ingress and subsequent leaks.
